## Hydrogen-Induced Cracking along the Fusion Boundary of Dissimilar Metal Welds

*The susceptibility of dissimilar austenitic/ferritic combinations to hydrogen-induced cracking near the fusion boundary has been investigated*

BY M. D. ROWE, T. W. NELSON AND J. C. LIPPOLD

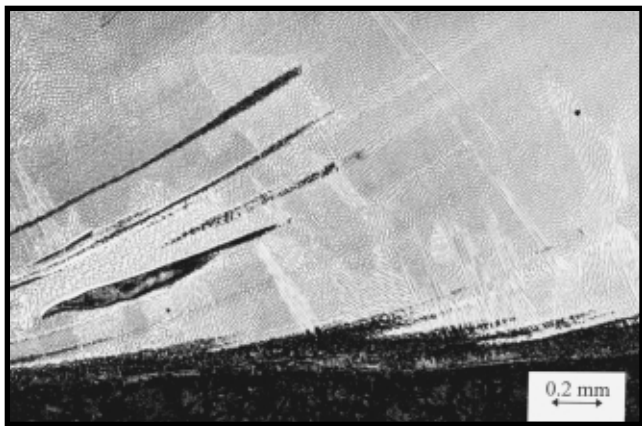
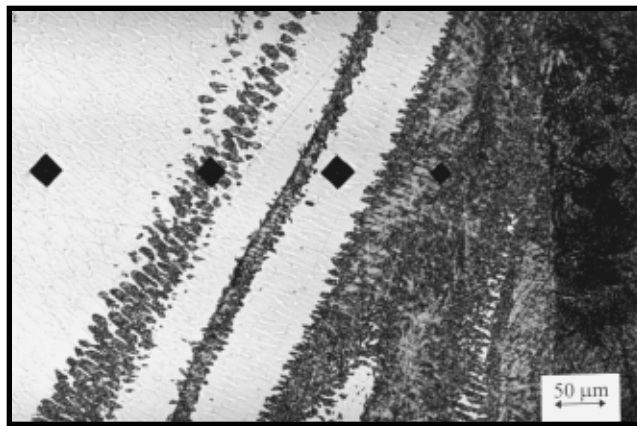
Fig. 7 — Plan view, ER309LSi filler metal, longitudinal strain, 33% dilution, pure argon shielding gas, chromic acid/nital/ferrofluid. A — Microstructure of mostly austenite with bands of martensite visible; B — bands of martensite near the fusion boundary.

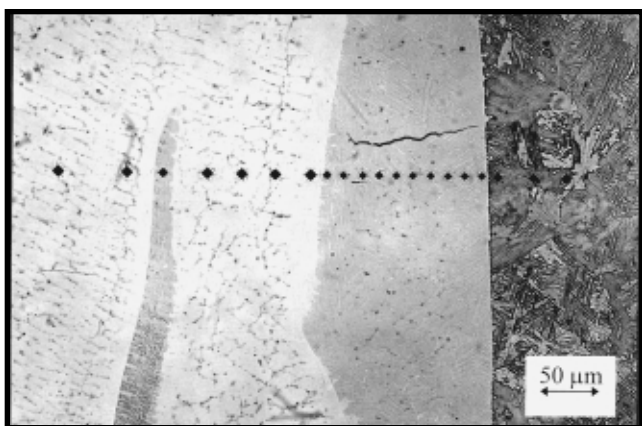
Fig. 8 — Plan view, ER309LSi filler metal, longitudinal strain, 38% dilution, Ar-6% $H_2$  shielding gas, chromic acid/nital etch showing a martensitic region (dark gray) near the fusion boundary containing a microscopic crack.

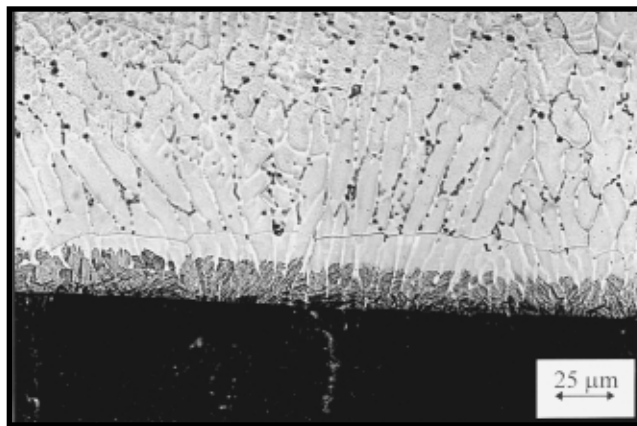
Fig. 9 — Plan view, same weld as Fig. 8, ferric chloride electrolytic etched revealed a martensitic microstructure near the fusion boundary and Type II grain boundaries.
