The Mechanism of Stress-Relief Cracking in a Ferritic Alloy Steel

A novel stress-relaxation technique and extensive microstructural characterization of the carbide precipitation, elemental segregation, and fracture modes were used to investigate stress-relief cracking in a ferritic alloy steel

BY J. G. NAWROCKI, J. N. DUPONT, C. V. ROBINO, J. D. PUSKAR, AND A. R. MARDER

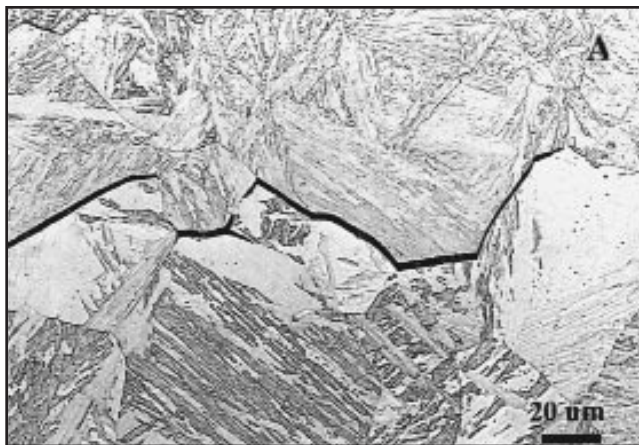
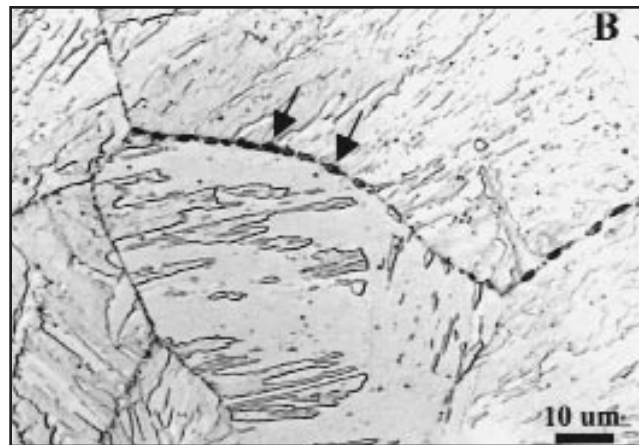
Fig. 2 — Representative LOM photomicrographs of failed samples viewed in cross section. Arrows indicate areas of void formation.

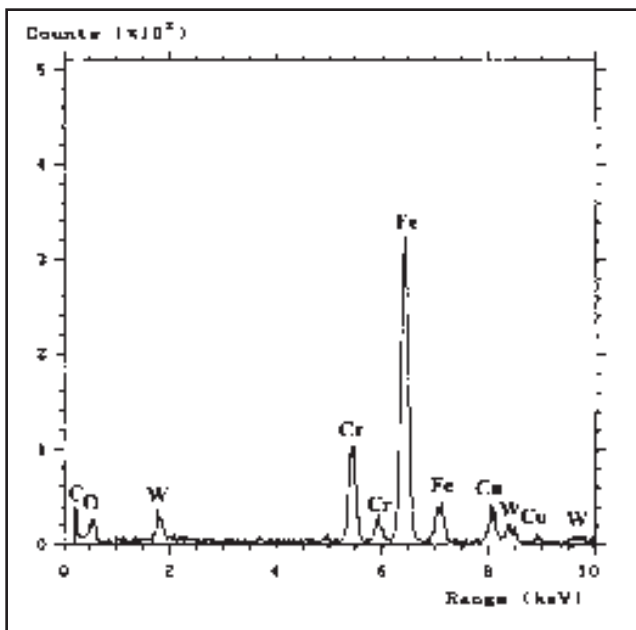
Fig. 8 — Representative EDS spectrum of Fe-rich M_3C found along prior austenite grain boundaries in the CGHAZ of failed stress relief cracking samples. Sample tested at 675°C.
