Liquation Phenomena in the Simulated Heat-Affected Zone of Alloy 718 after Multiple Postweld Heat Treatment Cycles

Delta-phase formation increases liquation cracking susceptibility

BY M. QIAN AND J. C. LIPPOLD

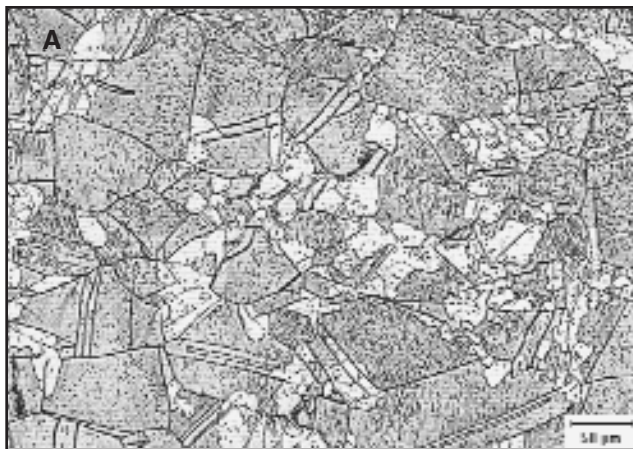
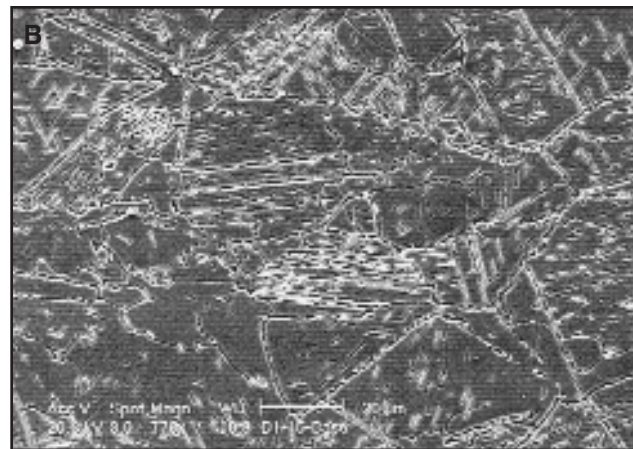
Fig. 1 — Microstructure of as-received Alloy 718 base metal: A — distribution of fine deformed grains at grain boundaries; B — short bar-shaped intra- and intergranular δ phase.

The material used in this study was Alloy 718 in the form of wrought plate. The composition of this material, based upon an independent analysis, is shown in Table 1. The plate microstructure in the as-received condition is shown in Fig. 1. There are fine deformed grains surrounding the “normal” grains and some δ phase is present in the γ -nickel matrix. Simulation of multiple PWHT cycles was accomplished through metallurgical-equivalent long-term isothermal heat treatments. This technique had previously been shown to yield microstructures and properties

718 is the high fraction of precipitated δ phase relative to that of the as-received material. The as-received base metal had relatively little δ phase and the size of intra- and intergranular bar-shaped δ phase is comparable — Fig. 1. In contrast, the fraction of both intra- and intergranular (IG) δ phase in the long-term, isothermally treated material increased dramatically, as shown in Fig. 3. The intergranular δ phase becomes essentially continuous as a result of the long-term isothermal treatment, and some bar-shaped δ phase along twin boundaries also became continuous. The morphology of the intragranular δ phase appears as fine needles that intercrossed compactly — Fig. 3B. There was no evidence of gamma double-prime (γ'') observed in this structure since the heat treatment temperature is above the precipitation range for γ'' and none would be

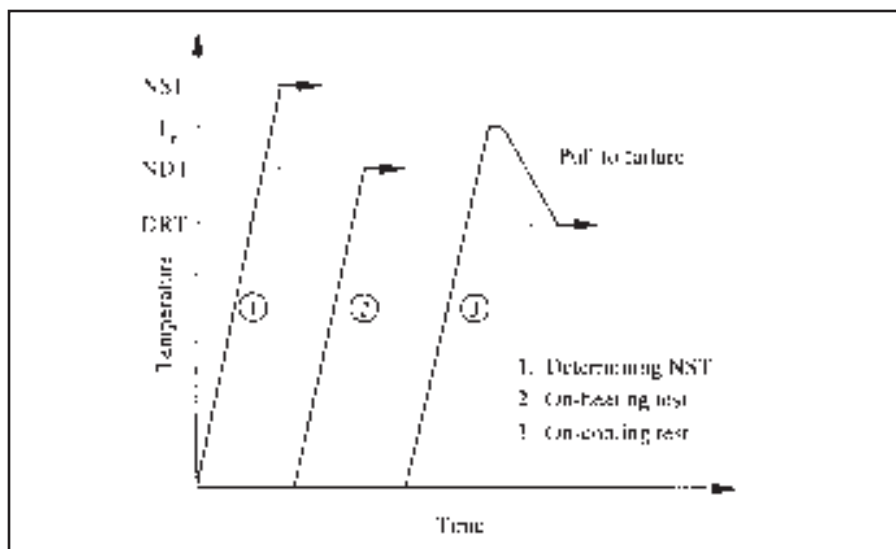
Fig. 2 — Schematic of Gleeble hot ductility test procedure.

Gleeble hot ductility testing was conducted to evaluate and compare the susceptibility of Alloy 718 to HAZ liquation cracking in three different conditions: 1) as-received, 2) 954°C/40 h, and 3) 954°C/100 h. The specimens are 6.35 mm in diameter, 100 mm in length, taken longitudinally along the rolling direction in the plate. The hot ductility testing follows conventional procedures as have been reported previously (Refs. 2–7). A heating rate of 111°C/s, hold time at test temperature of 0.5 s, cooling rate of 43°C/s (for on-cooling tests), and stroke rate of 25 mm/s were used. All testing was conducted under an argon atmosphere. Figure 2 schematically shows the procedure for determining critical values of nil-strength temperature (NST), nil-ductility temperature (NDT), and ductility-recovery temperature (DRT). Initially, the nil-strength temperature (NST) was determined by heating the specimen under a small static load (approximate 10 kg) until failure occurred. On-heating hot ductility tests were conducted by heating samples to various test temperatures, and pulling them to failure at the stroke rate reported, until NDT was achieved. On-cooling tests were performed after heating to a peak temperature (T_p) between the NDT and NST, and then cooling to a desired temperature, and pulling to failure to identify the DRT.

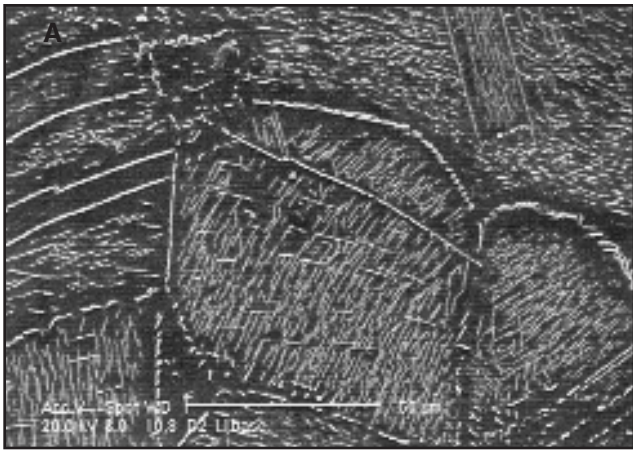
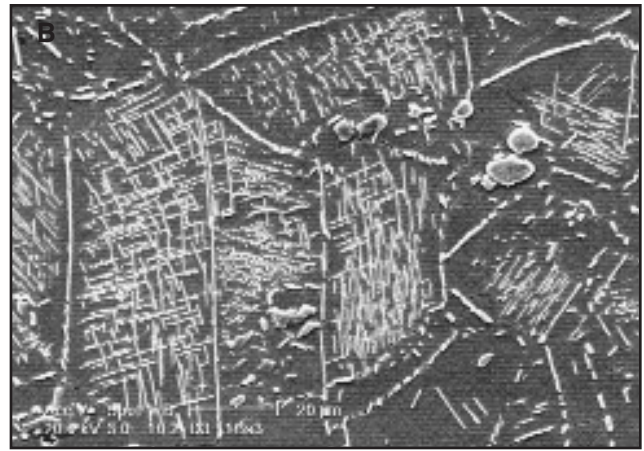
Fig. 3 — High fraction of needle-shaped intragranular and bulky continuous, intergranular δ phase from long-term isothermal treatment. A — 954°C/40 h; B — 954°C/100 h.

The grain size remained essentially constant after the long-term isothermal heat treatment at 954°C , as shown in Table 2. This is due to the pinning effect of the δ phase on grain boundaries. The bulky angular phases in the nickel matrix (Fig. 3B) are carbides that are distributed as stringers in the rolling direction of the wrought plate.

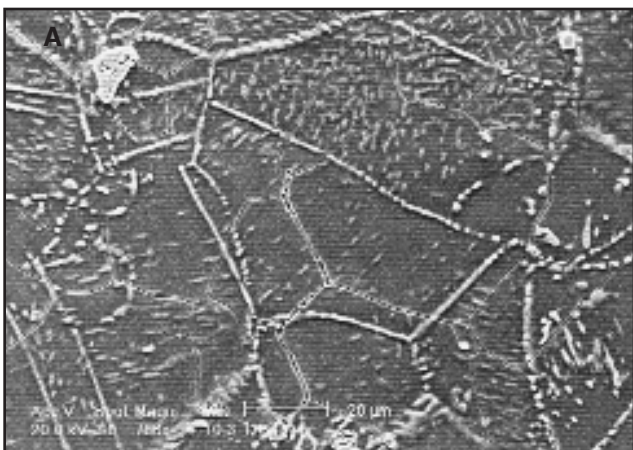
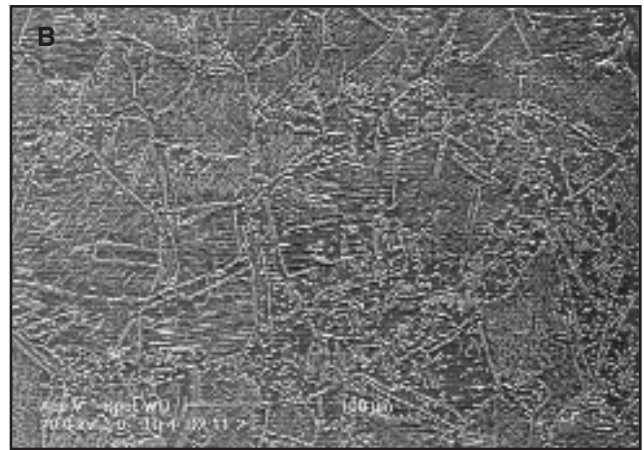
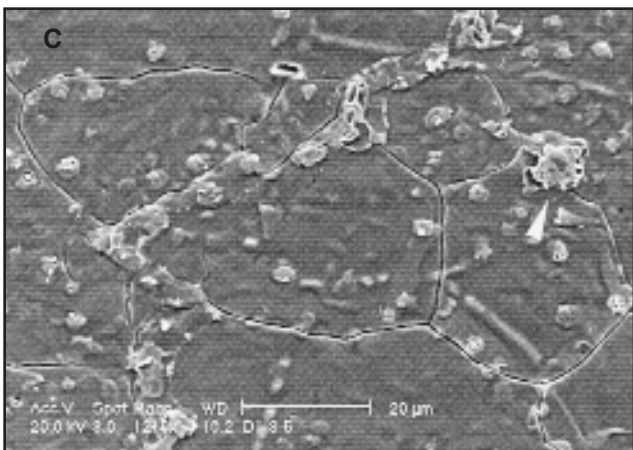
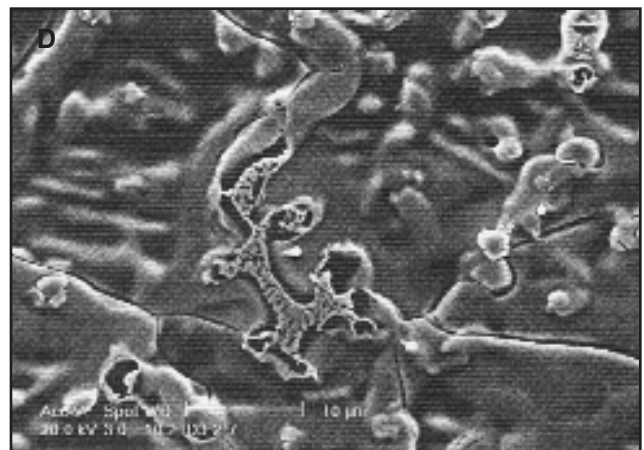
Fig. 4 — δ -phase dissolution during simulated HAZ thermal cycles in Alloy 718. A — δ -phase “thickening” at NDT of the as-received material; B — dissolving δ -phase network at NDT of 954°C/40 h treated material; C — δ phase “rounding” at NST of the as-received material (liquefied boron carbide is indicated); D — interconnected cluster of B- and Nb-rich eutectic constituents from dissolved δ -phase along grain boundaries at NST of 954°C/100 h-treated material.

Figure 4 shows microstructural evidence of δ -phase dissolution and associated liquation. The dissolution of the δ phase results in Nb enrichment at the grain boundary that gives rise to the different etching characteristic of the boundary. The Nb-enriched boundary varied as a function of the peak temperature reached during the hot ductility test and is manifested microstructurally by different morphologies. At the NDT, the mi-

crostructure appears as δ -phase needle “thickening,” as shown in the as-received material — Fig. 4A. Note that the “holes” along the GBs are sites of eutectic, δ -phase dissolution products that have etched out of the structure. Fracture surface analysis in the SEM revealed additional details of the liquation process, including apparent constitutional liquation of boron carbides.

but slightly rounded particles and holes where particles have dropped out of the fracture surface — Fig. 6A and B. EDS analysis revealed that the particles are complex boron carbides containing Cr, Ti, and some Nb. The presence of round holes accommodating the rounded boron carbides suggests that boron carbide-related constitutional liquation has occurred along the GBs. Heating of the densely distributed δ phase in 954°C-treated samples to the NDT produced more extensive, dissolving δ phase networks — Fig. 4B. As the test temperature was raised to the NST, δ -phase dissolution became more pronounced. The once-thickened, intragranular δ -phase needles began “rounding” (Fig. 4C and D), indicating a more accelerated Nb dissolution rate. Some adjacent dissolved δ phase near or along GBs interconnected to form B- and Nb-rich eutectic constituents — Fig. 4D. These low-melting eutectic liquids along GBs will result in GB weaken-

Figure 8 presents secondary electron (SE) and back-scattered-electron (BSE) micrographs that clearly show the morphology of boron carbides (lighter bulky phase) and MC carbides (dark phases), where boron carbide has apparently decomposed from its periphery. A similar case can be seen in Fig. 4C (arrow) and is probably due to constitutional liquation.

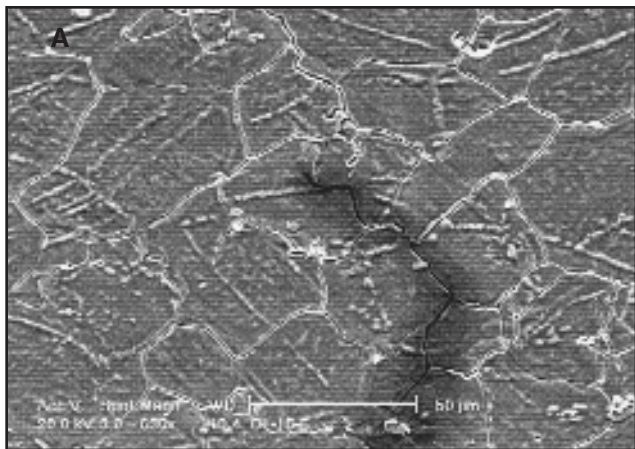
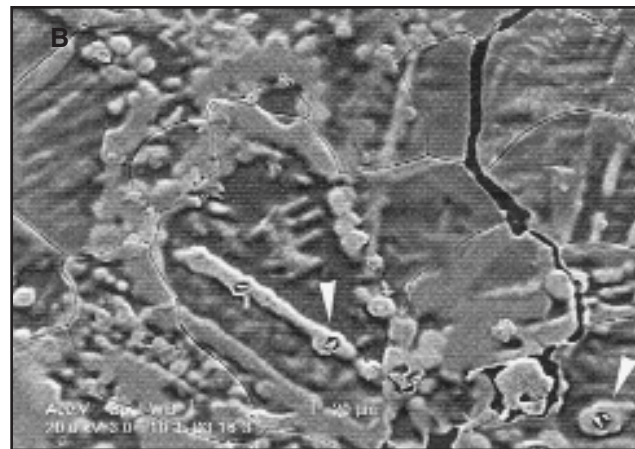
Fig. 5 — δ -phase dissolution gradient in DRT specimens. A — As-received; B — 954°C/100 h treated condition (arrows indicate eutectic constituents formed in the cores of original δ phase).

At the DRT, the microstructures of as-received 718 (Fig. 5A) did not change much compared with that of the NDT sample (Fig. 4A). However, the Nb dissolution is more extensive (Fig. 5B) than that at the NDT since this sample has been heated through the peak temperature (T_p) during the on-cooling test. It can also be observed that tiny but distinguishable eutectic constituents form in the center of the original δ phase — Fig. 5B. This is due to the Nb enrichment associated with the dissolved δ phase. The center has a higher concentration of Nb, while the periphery has a lower concentration of Nb. As the high concentration of Nb corresponds to the eutectic with a lower melting point (1175°C), liquation started preferentially at the center when temperatures became favorable.

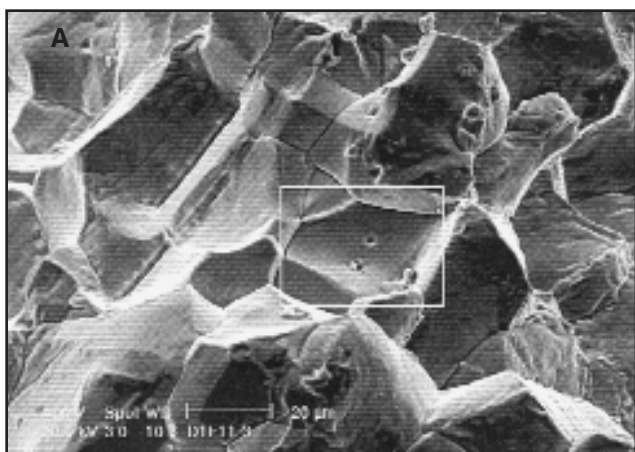
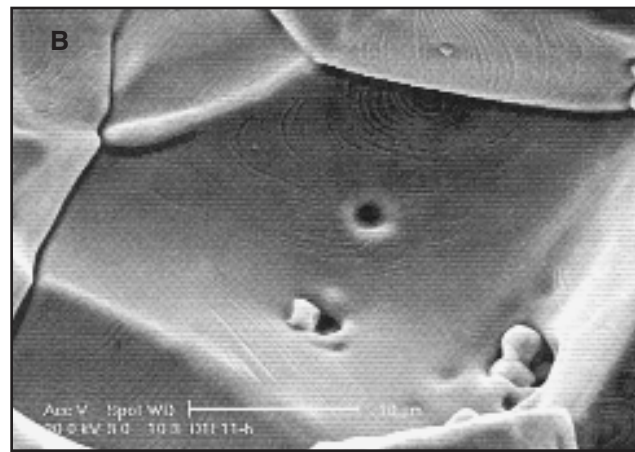
Fig. 6 — Fractography of NDT samples of as-received Alloy 718. A — Intergranular fracture; B — detail of Fig. 6A showing evidence of liquid films and liquated boron carbides.

Typical intergranular features are shown in Fig. 6, where liquated particles and evidence of liquid films on the fracture surface can be seen. Note the angular

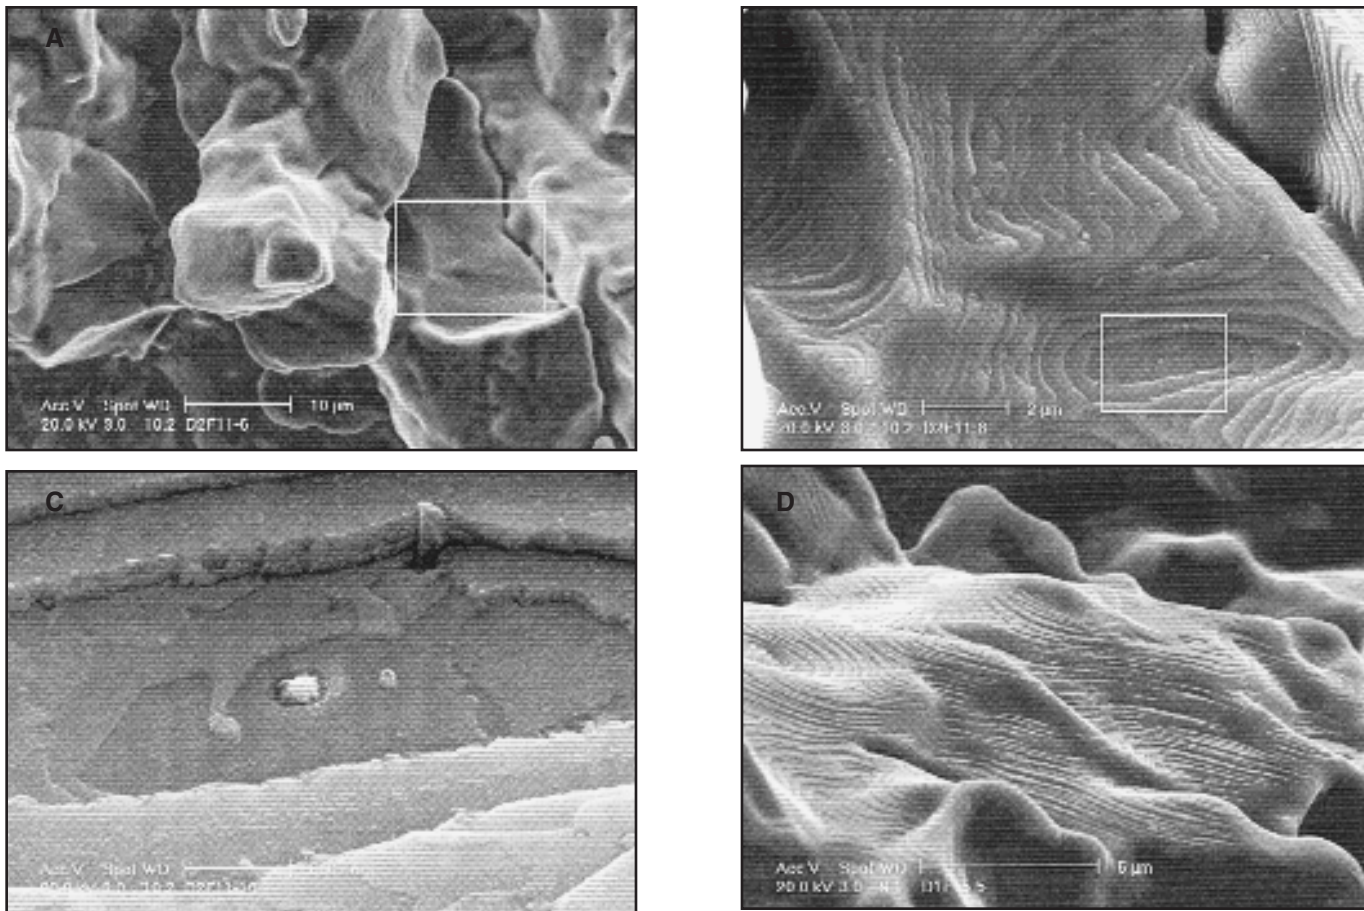
Fig. 7 — Fractography of 954°C/40 h-treated specimens. A — IG feature at NDT; B — detail of Fig. 7A showing terraced ripple pattern with particles dispersed at NDT; C — detail of the liquated boron carbide; D — terraced ripple pattern of liquid flow trace at DRT.

Figure 7 shows intergranular fracture of the 954°C-treated samples, but with more liquid present than seen in Fig. 6 for the as-received material. There are more particles on these fracture surfaces and the flow pattern of the liquid films is much

more evident, appearing as terraced ripple patterns. At the center of concentric ripples, a liquated particle in a hole was identified as a Nb-rich boron carbide, as shown in Fig. 7B and C. Similar but smaller particles can also be differentiated in the same micrograph. The angular particle at the upper right has not liquated and was identified as TiC. More GB liquation associated with ripple patterns can be seen in Fig. 7D.

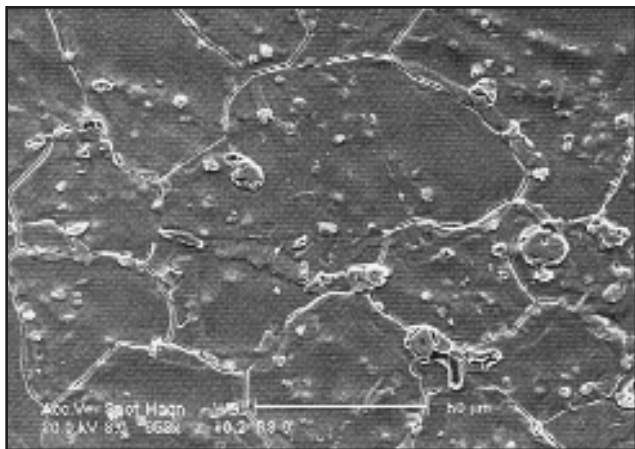
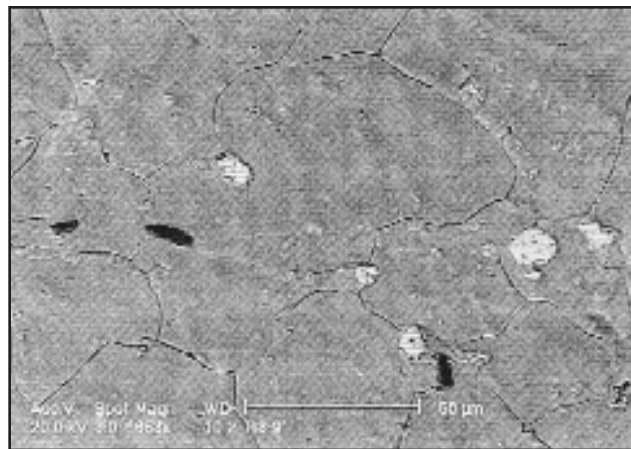
Fig. 8 — Morphology of boron carbides and MC carbides in a DRT specimen. A — SEM showing rounded δ phase and associated liquation; B — BSE image differentiating phases in the γ -nickel matrix.
